Manhole Inspection Summary

Manhole # S69S__001MH

Record Plat: **69S** Node: **001** Status: **Found**

Location Address: **6600 Hartwait St.**

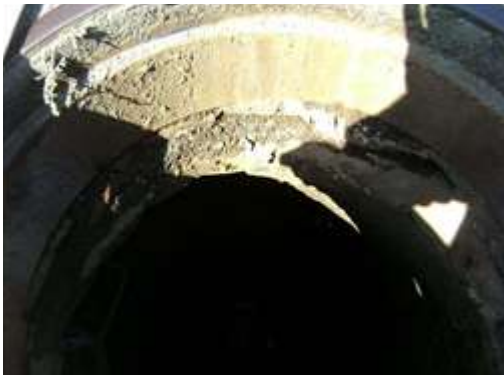
Defect 1

Offset: **1** (in.)

offset frame defect

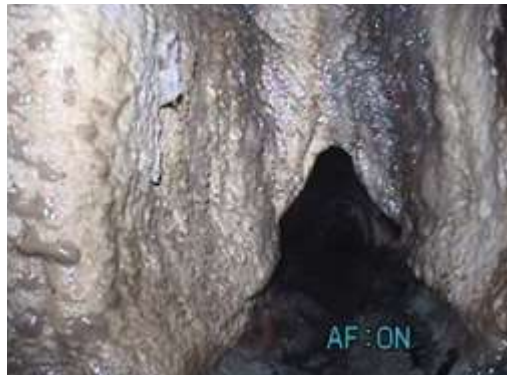
Defect 3

heavy mineral encrustation on I3

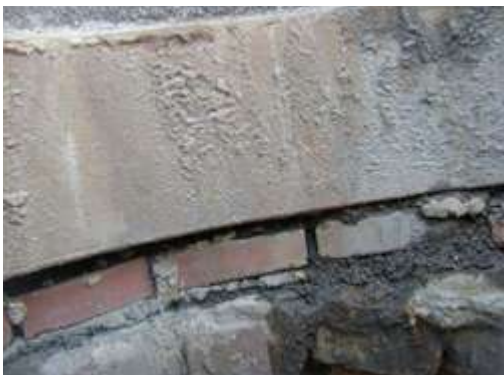
Defect 2

Condition: ☐ Sound ☐ Cracked ☐ Root Intrusion ☒ Loose Brick ☒ Deteriorated

Infiltration: ☐ None ☐ Joint ☐ Cracks ☒ Mortar ☐ Roots ☐ Wall

Loose bricks and missing mortar in chimney

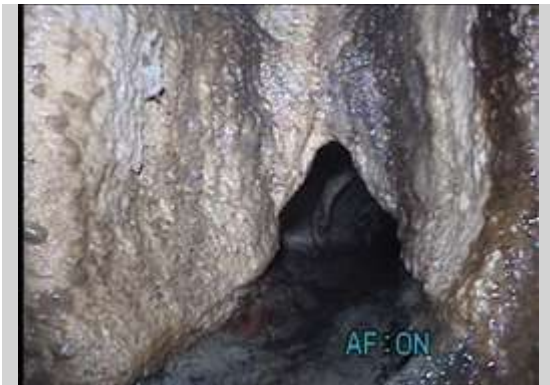
3 O'Clock Inflow

Pipe Height: **8.4** (in.) Rod and Bar (Angled)
Pipe Material: **Clay** ☐ Pipe Lined
Invert Depth: **14.92** (ft.) Flow Characteristics: **Fast**
Deposits: ☐ None ☐ Mud ☒ Sludge ☒ Debris ☐ Grease
Silt Depth: **1** (in.) Deposits Extent: **Light**
Infiltration: **None** Pipe Seal Cond: **Sound**
